MICHIGAN DEPARTMENT OF ENVIRONMENTAL QUALITY  
 LAND AND WATER MANAGEMENT DIVISION  
**DAM INSPECTION REPORT**

DAM NAME LAKE CHEMUNG		DAM ID 1980	COUNTY LIVINGSTON
DATE OF INSPECTION 07/26/06	NAME OF WATERBODY LAKE CHEMUNG	SECTION, TOWN, RANGE Sec. 4 T 2N R 5E	LEVEL THIS DATE 957.98+/-
DATE ELEVATION SET BY COURT 12/14/1925	LEGAL LEVEL 957.98	DRAWDOWN LEVEL 957.98	HIGH WATER MARK ELEVATION 958.9

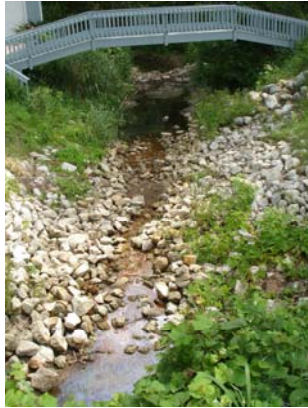
**Name:** DSC00128  
**Date Modified:** 7/27/2006 8:55:00 AM  
**Date:** 7/27/2006 8:54:58 AM  
**Description:** Looking downstream of control structure

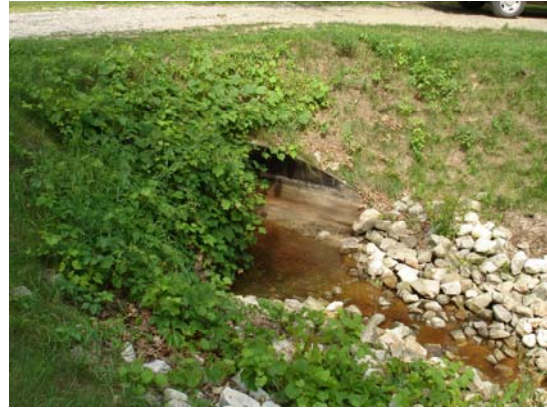
**Name:** DSC00129  
**Date Modified:** 7/26/2006 11:36:22 AM  
**Date:** 7/26/2006 11:36:22 AM  
**Description:** Downstream face of pipe under driveway

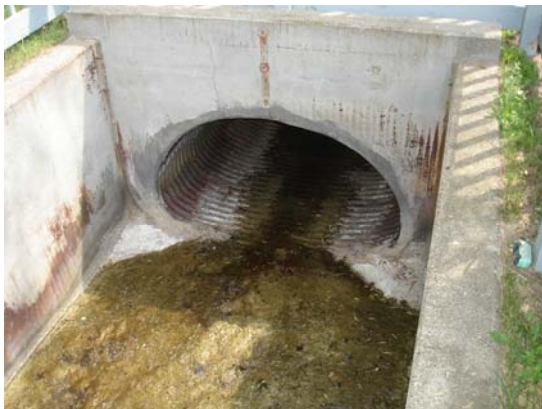
**Name:** DSC00130  
**Date Modified:** 7/26/2006 11:37:08 AM  
**Date:** 7/26/2006 11:37:08 AM  
**Description:** Upstream face of pipe under driveway

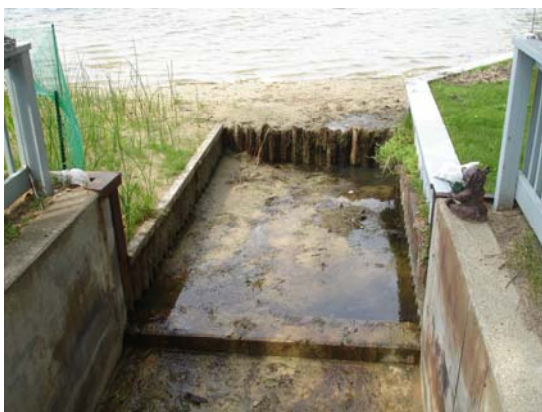
**Name:** DSC00132  
**Date Modified:** 7/26/2006 11:37:54 AM  
**Date:** 7/26/2006 11:37:54 AM  
**Description:** Looking upstream at control structure

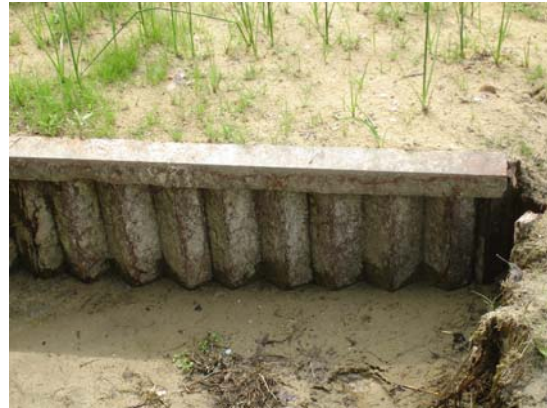
UPSTREAM	CROWN	DOWNSTREAM
VEGETATIVE COVER	GRASS	GRAVEL/GRASS	GRASS
EROSION	NONE VISIBLE	NONE VISIBLE	NONE VISIBLE
SEEPAGE			NONE VISIBLE
SLIDES, SLUMPS & CRACKS	NONE VISIBLE	NONE VISIBLE	NONE VISIBLE
ANIMAL BURROWS	NONE VISIBLE	NONE VISIBLE	NONE VISIBLE
WAVE ACTION PROTECTION	SEAWALLS AND NATURAL SHORELINE		RIPRAP
REMARKS*	RUSTED SHEET PILING	CONCRETE IN GOOD CONDITION

**Name:** DSC00138  
**Date Modified:** 7/26/2006 11:39:20 AM  
**Date:** 7/26/2006 11:39:20 AM  
**Description:** Rusted sheet pile of control structure

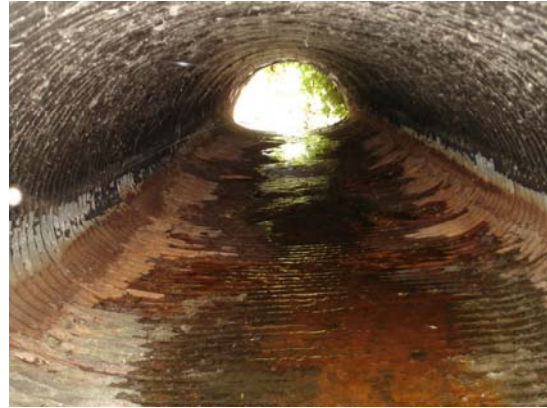
STOPLOG VALVES AND GATES (open and close to check condition): Check location of top stoplog in relation to top of riser pipe intake box or fixed crest, for leakage, and condition of stoplogs, valves and gates. NA
OUTLET PIPE: Check for damage from ice, logs, vandalism; inside discharge pipe for settlement and/or joint separation; condition of pipe coating. CMPA RUSTING – 5-10 YEARS LEFT/ PROTECTIVE COATING HAS DETERIORATED AND COULD USE LINING.

**Name:** DSC00142  
**Date Modified:** 7/26/2006 11:40:26 AM  
**Date:** 7/26/2006 11:40:26 AM  
**Description:** Rusted CMP pipe under driveway

POSSIBLE LINE OR REPLACE OUTLET PIPE, REMOVE SAND IN FRONT OF SHEETING
